Water Compliance Inspection Report

Name and Location of Facility Inspected (For industrial users discharging to POTW, also include POTW name and NPDES permit number) Hecla Ltd. Lucky Friday Mine and Mill 397 Friday Avenue Mullan, ID 83846	Entry Time/Date 8:00 am / 05/18/15	Permit Effective Date 12/01/2006
	Exit Time/Date 12:05 pm / 05/19/15	Permit Expiration Date 09/14/2008; admn extnd
Name(s) of On-Site Representative(s)/Title(s)/Phone and Fax Number(s) Bradley Kucera, P.E., Environmental Manager 208-744-1751, ext. 2349 (w); 208-661-5247 (m) BKucera@hecla-mining.com	Other Facility Data (e.g., SIC NAICS, and other descriptive information) SIC Code 1044 NAICS Code # 212222	
Name, Address of Responsible Official/Title/Phone and Fax Number Clayr Alexander, VP and General Manager Hecla Ltd., Lucky Friday Mine and Mill P.O. Box 31, Mullan, ID 83846 1-208-74401751, ext. 2304	Clayr Alexander replaces former Mine Manager Ed Sutich (I verified that this is the correct spelling for Mr. Alexander). Though I did not contact Mr. Alexander personally, he was aware of our presence at the mine. <div style="text-align: center;"> Contacted <input type="checkbox"/> Yes <input checked="" type="checkb

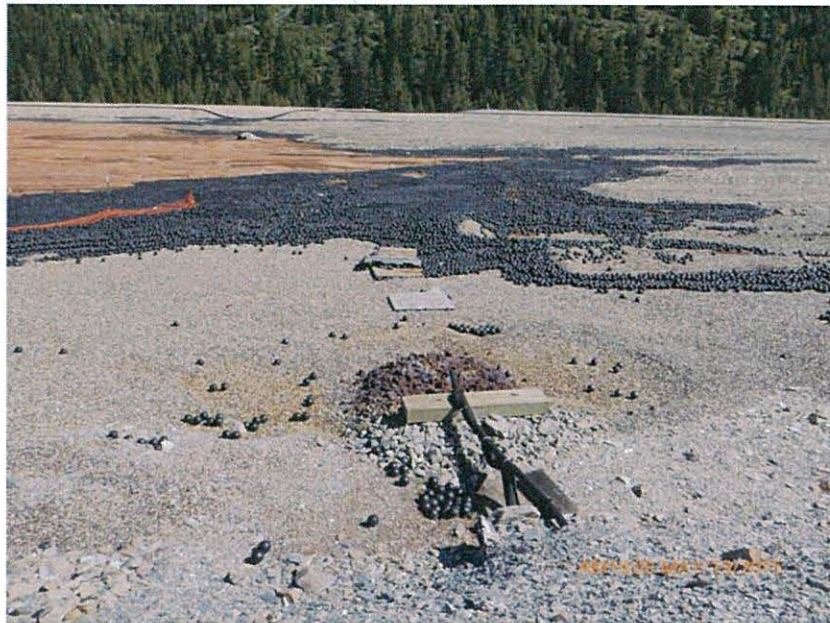
Photo No. 4 (P1010235)

Facing north – this is the east end of Tailings Pond 3; the black objects are “bird balls” that were once used as a floating cover and water fowl deterrent.

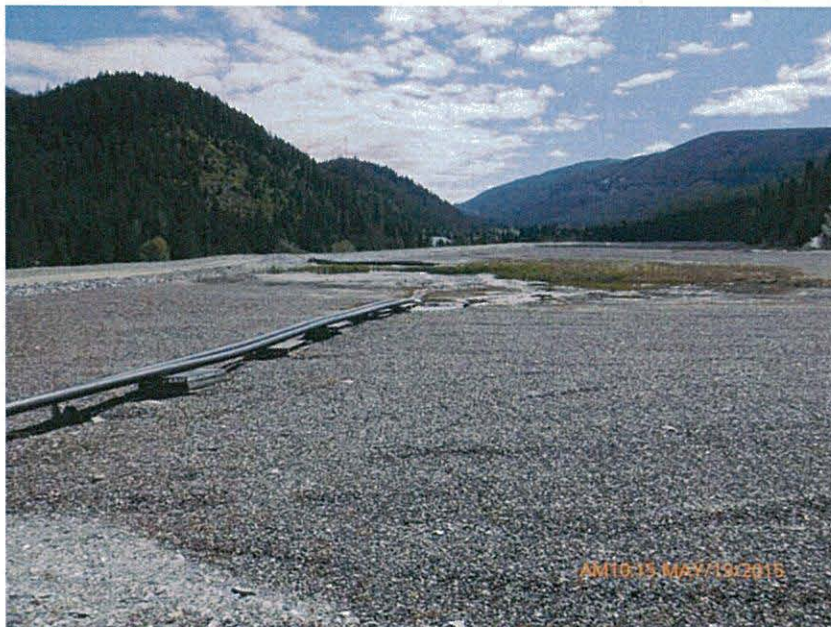
Photo No. 5 (P1010238)

Facing northwest – this is the west side of Tailings Pond 3.

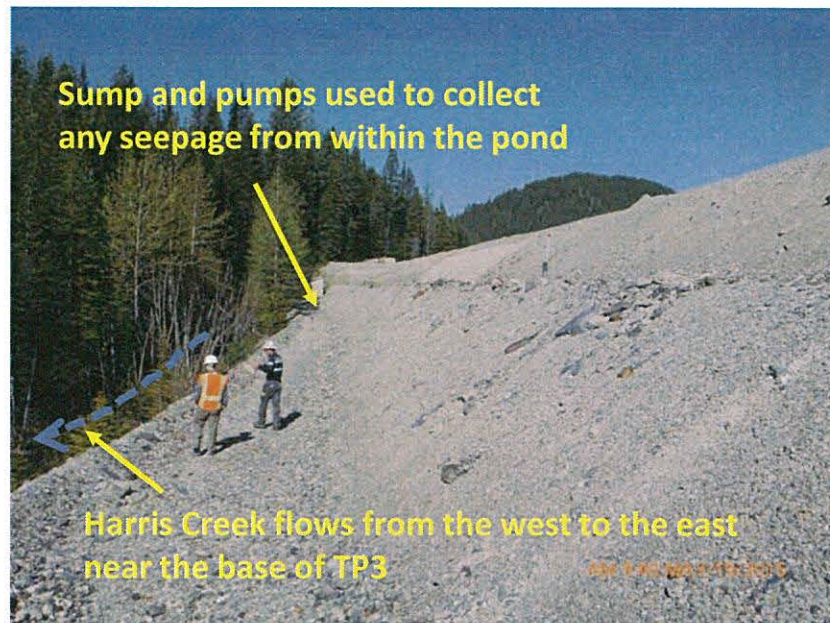
In the *Facility Background* section of this report (Section V), I described a recent settlement agreement entered into by and between EPA and Hecla Ltd. The agreement included a \$600,000 penalty for "water pollution violations" at the Lucky Friday. TP3 was one of two locations involved in the penalty assessment. One of the penalty issues at TP3 came to EPA's attention during the course of a routine NPDES inspection in February 2010. At that time, what appeared to be an unreported seep was discovered by

EPA inspectors along a bench located midway between the toe and the crest of TP3 on the south exterior wall of the tailings pond (the horizontal "bench" was created when a new stage was added to the top of the pond). Further investigations suggested that the seep was associated with a mixture of stormwater and mill tailings from within the pond. The seepage was of particular concern since Harris Creek, a tributary of the SFCdA, flows past the southeast end of TP3. A section of Harris Creek is located approximately 20' from the area where the seepage was observed. To address this issue, Hecla installed a French drain within a 550' horizontal segment of the south face of the tailings pond (see Photos 7-8). The French drain is intended to intercept any seepage from within the pond and divert it to a concrete sump equipped with a float-activated pump. This water is then pumped back into TP3.

Photo No. 7 (P1010232)
Facing west – this is the south side of TP3. A seep was observed in this area during a 2010 inspection.

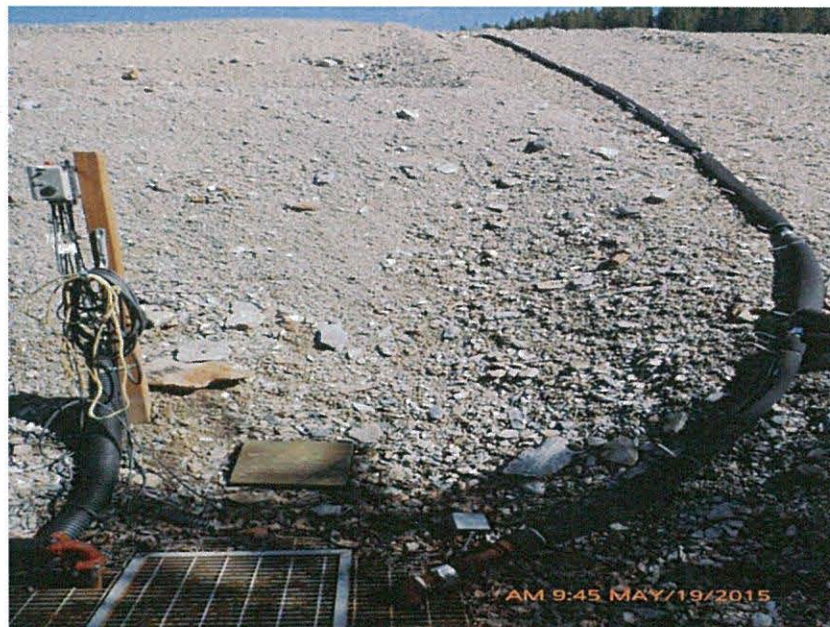
Photo No. 8 (P1010233)
Facing north – this is the sump noted in the previous photo (Photo 6). Water collected in the French drain flows into this sump from horizontal laterals extending from each side of the sump. Water collected in the sump is pumped back into Tailings Pond 3.

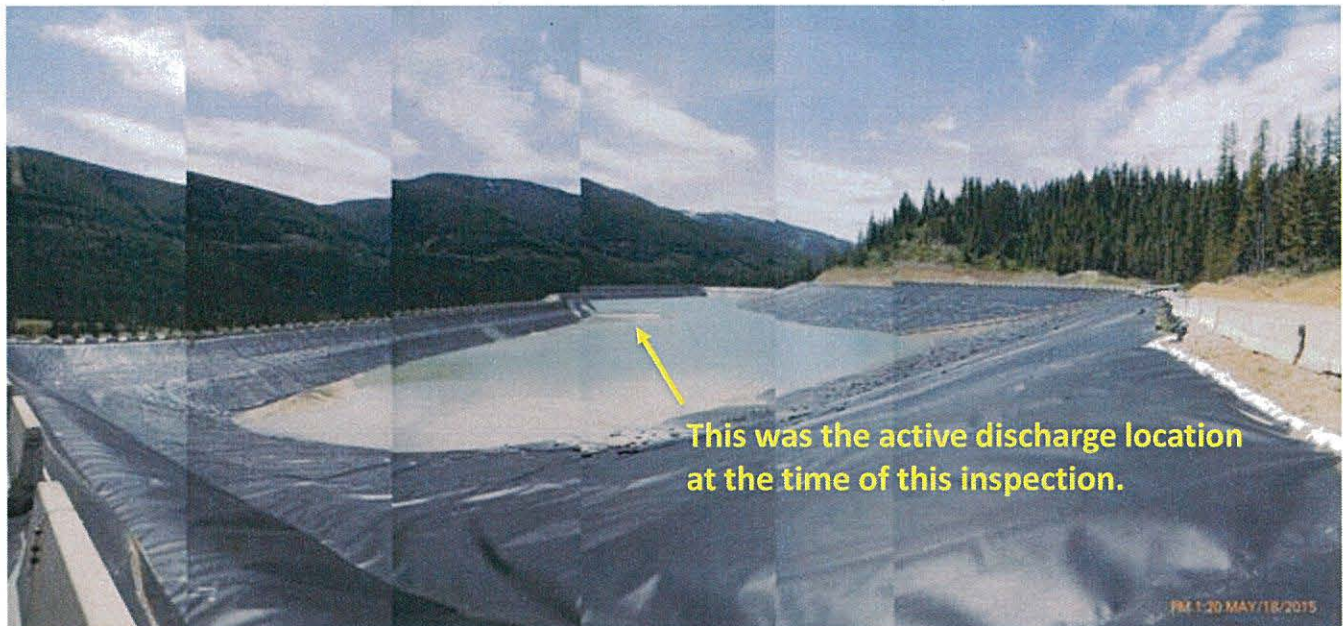
Photo No. 9 (P1010183 – P1010188)

Facing west southwest – this is TP4. The discharge location for the tailings can be changed to prevent the formation of beaches that could isolate parts of the pond.

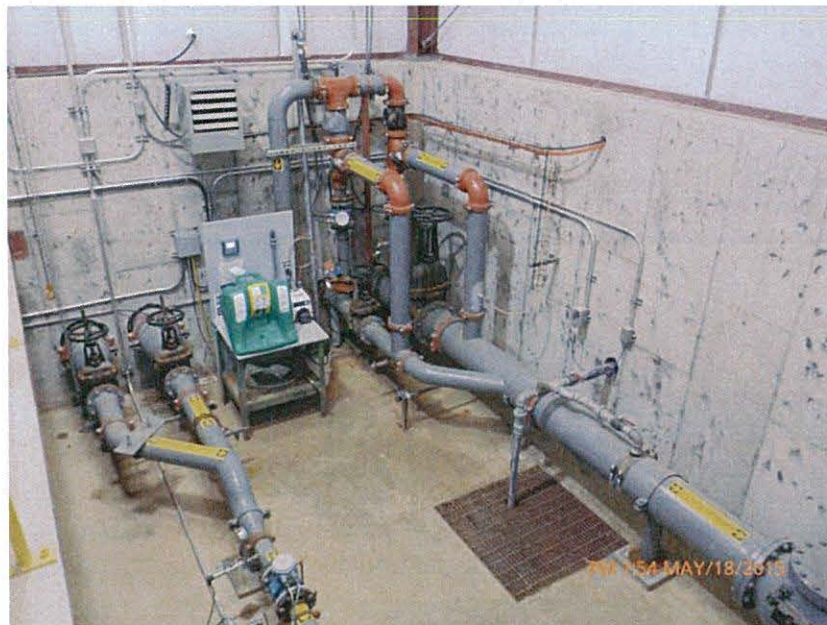
Wastewater collected in the TP4 underdrain and toe drain described in Ms. DeMaria's inspection report combines with the decant line from TP4 in the "Junction Box Building" (JBB) located near the base of TP4 (see Photos 12-15). The combined waste streams flow under gravity to WWTP3. The foundation drain mentioned in Ms. DeMaria's report flows from the JBB to an adjacent infiltration basin.

Photo No. 13 (P1010204)
The various drains associated with TP4 are all routed to and through the junction building. The toe, decant, and underdrain flow downhill to WWTP 3 (some may be diverted for make-up water in the mill). Water from the foundation drain discharges to adjacent infiltration basin.

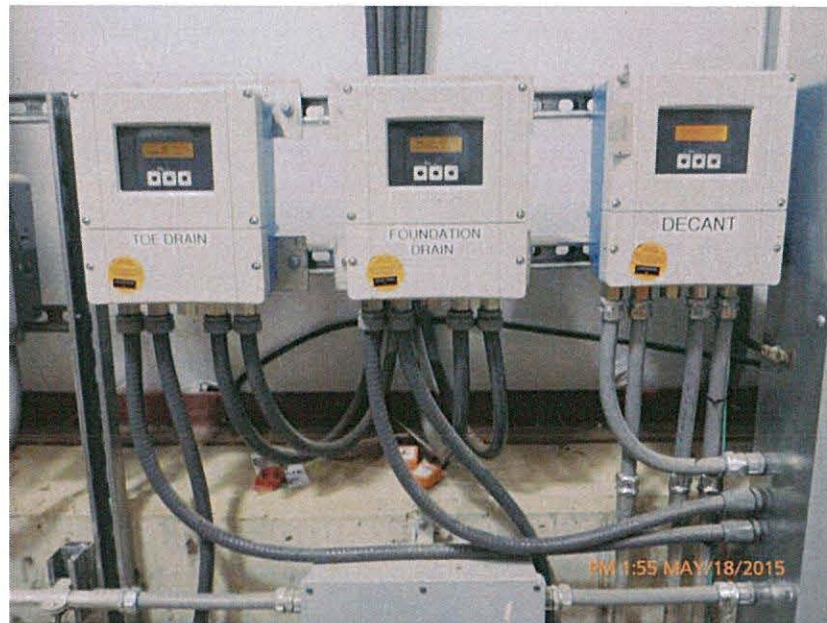
Photo No. 14 (P1010205)
The volume of water flowing through the TP4 drains is continuously monitored in the junction building.

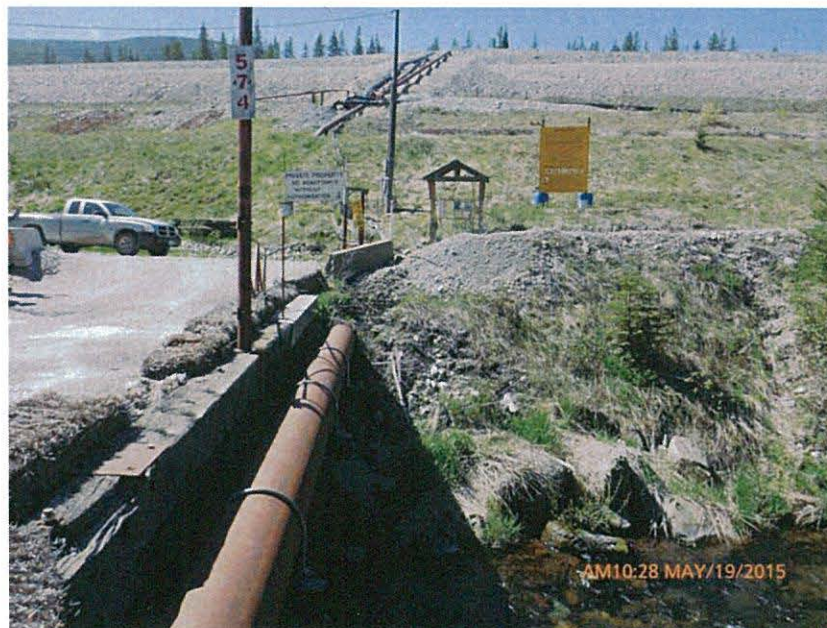
Photo No. 15 (P1010240)
Facing south – the drain water from TP4 flows downhill and crosses the SFCdA midway along the north side of TP3. There is sufficient head to lift the water to the piping system along the top of TP3.

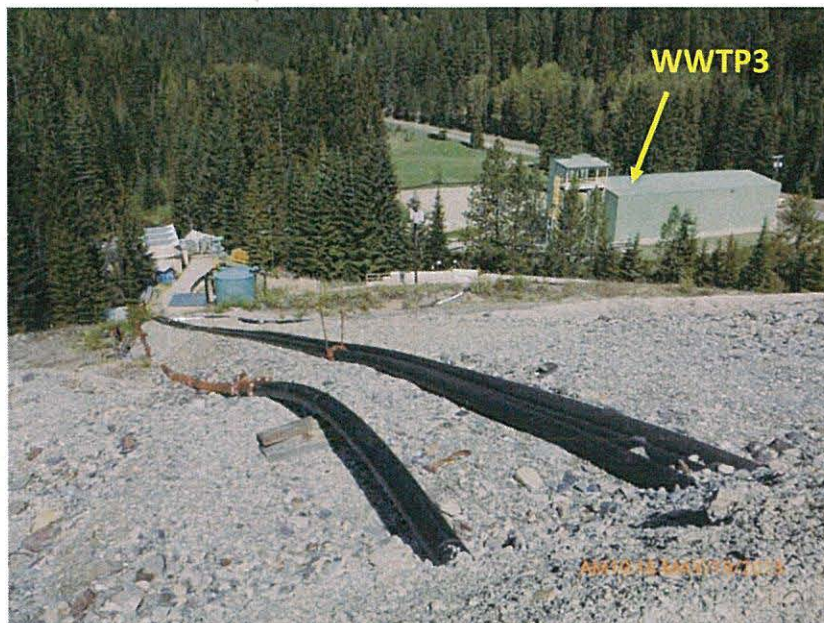
Photo No. 16 (P1010239)

Facing west – the larger line on the right, sitting atop the crest on the north side of TP3, delivers the drain water from TP4 to WWTP3. The line on the left conveys water from TP3 to WWTP3.

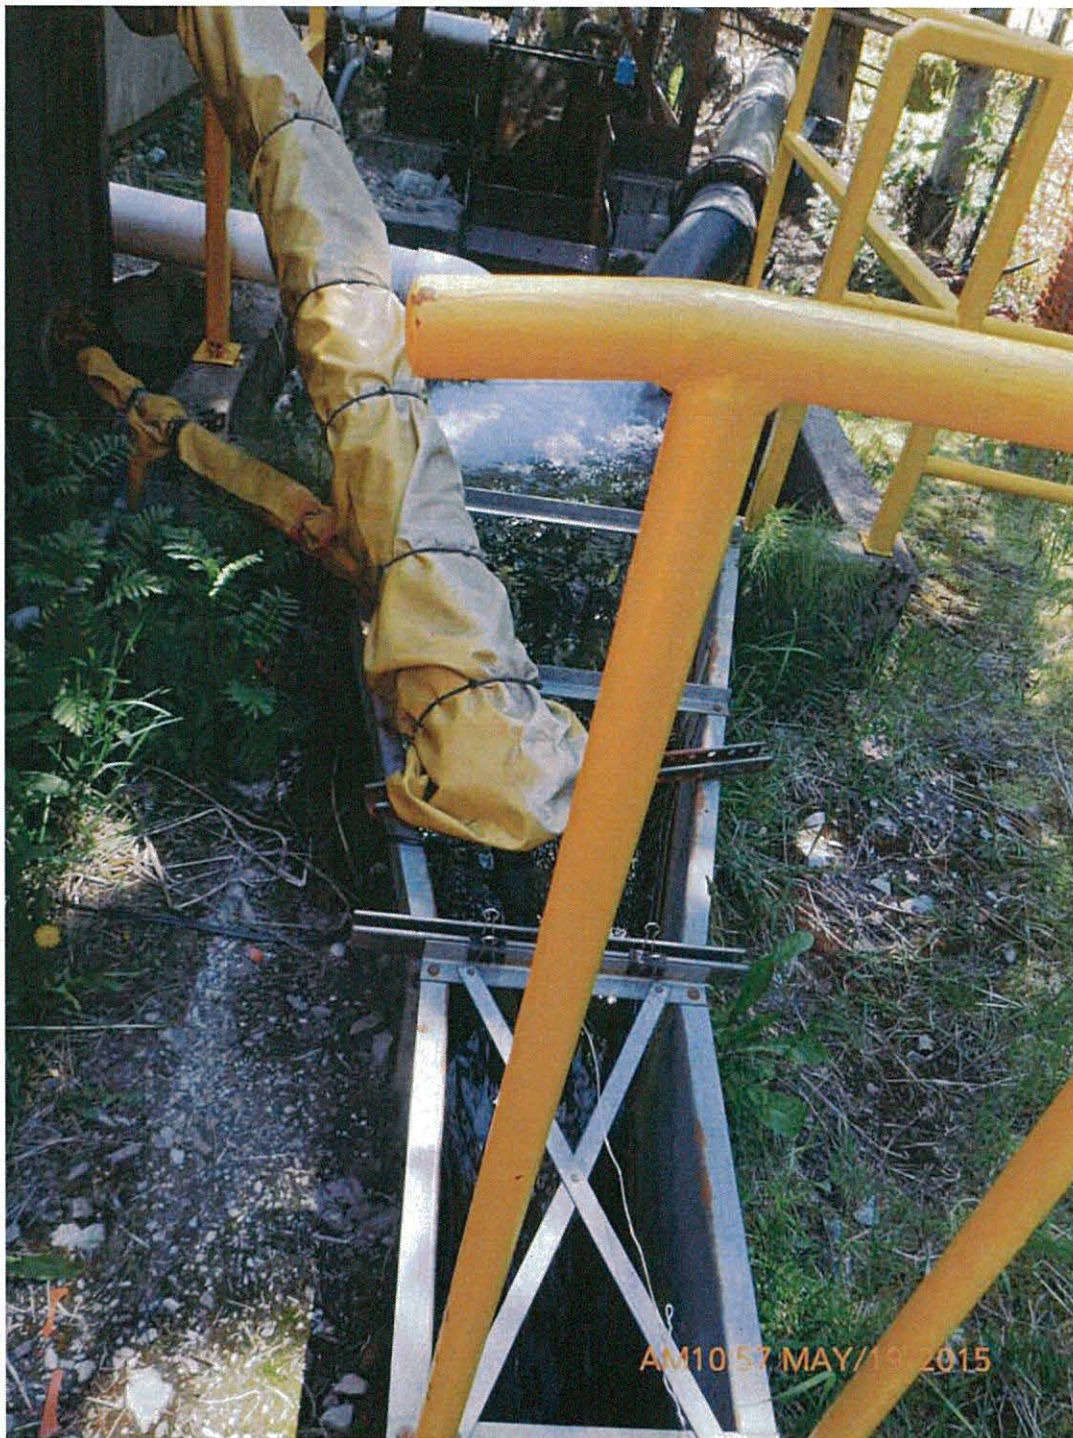
Photo No. 18 (P1010245)

The treated wastewater from WWTP3 flows through this Parshall flume before discharge to the SFCdA.

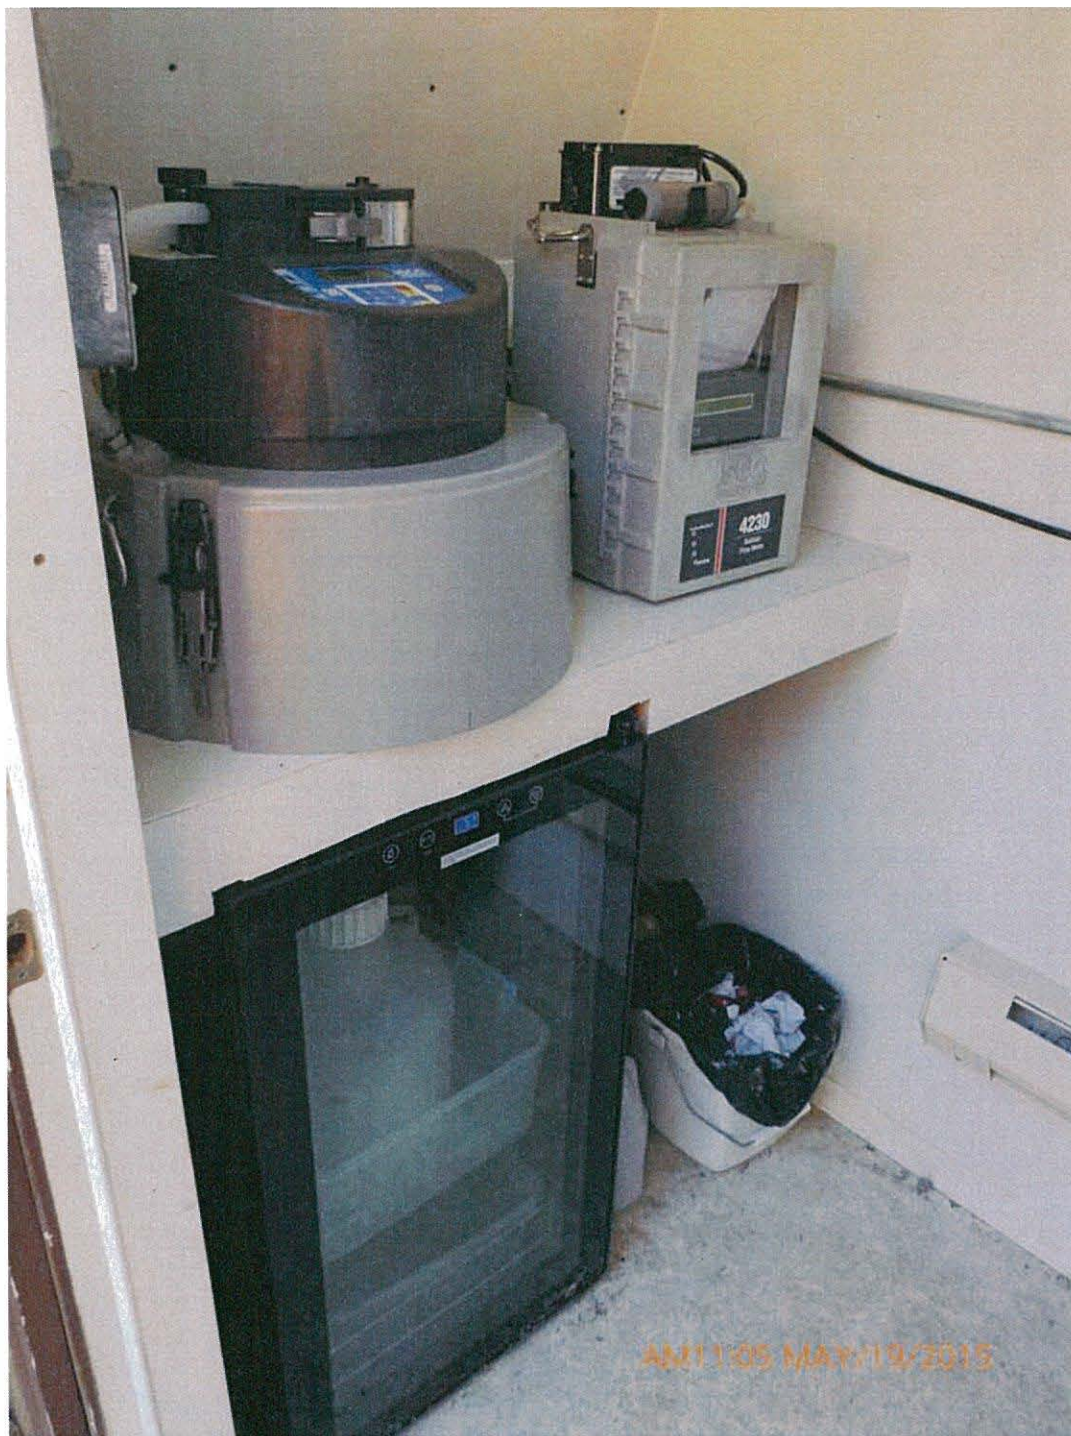
Photo No. 19 (P1010248)

This ISCO sampler is used to collect composite samples of the discharge from WWTP3 to the SFCdA.

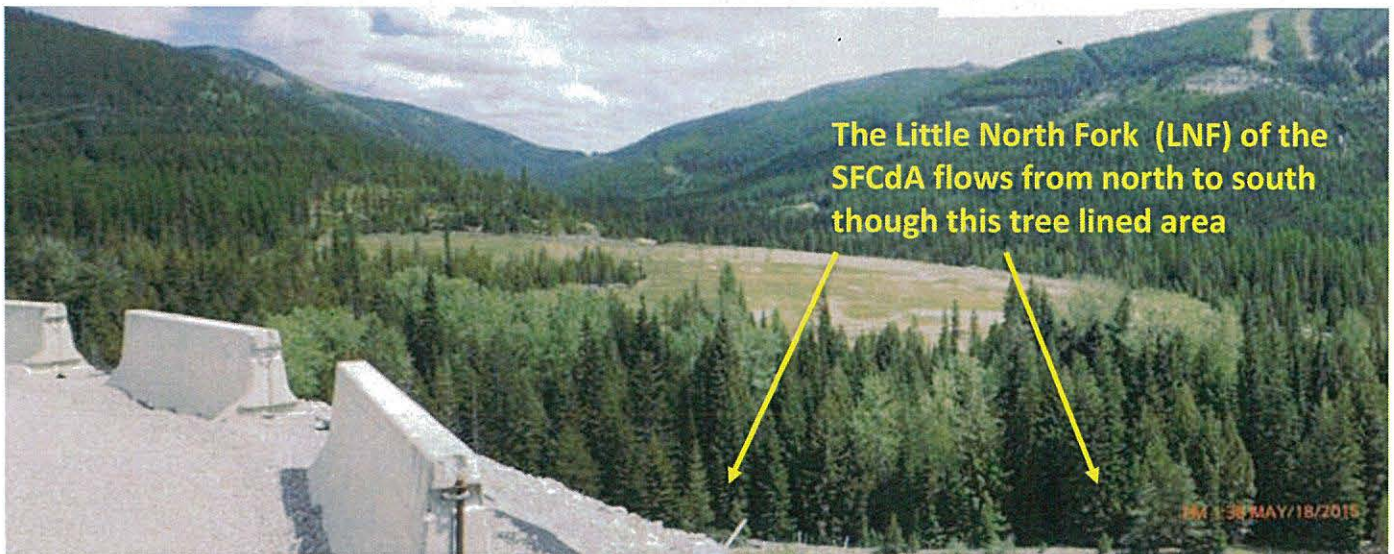
Photo No. 20 (P1010200 – P1010201)

On November 27, 2012, while conducting other stormwater inspections in North Idaho, I responded to a complaint involving the discharge of sediment-laden stormwater runoff from the “borrow source” used during the construction of TP4. The 22 acre borrow source was located on the east side of the Little North Fork (LNF) of the SFCdA River (see Photo 20). Approximately one week earlier, a major rainfall event had caused a signification discharge of sediment-laden stormwater to the LNF a short distance above the Hale Fish Hatchery (see my *Hecla Ltd., Lucky Friday Unit, November 27, 2012 MSGP Complaint-Based Inspection Report*). The staff at the Lucky Friday failed to

Facing east from atop TP4 – the bare area was the former borrow source used during the construction of TP4.

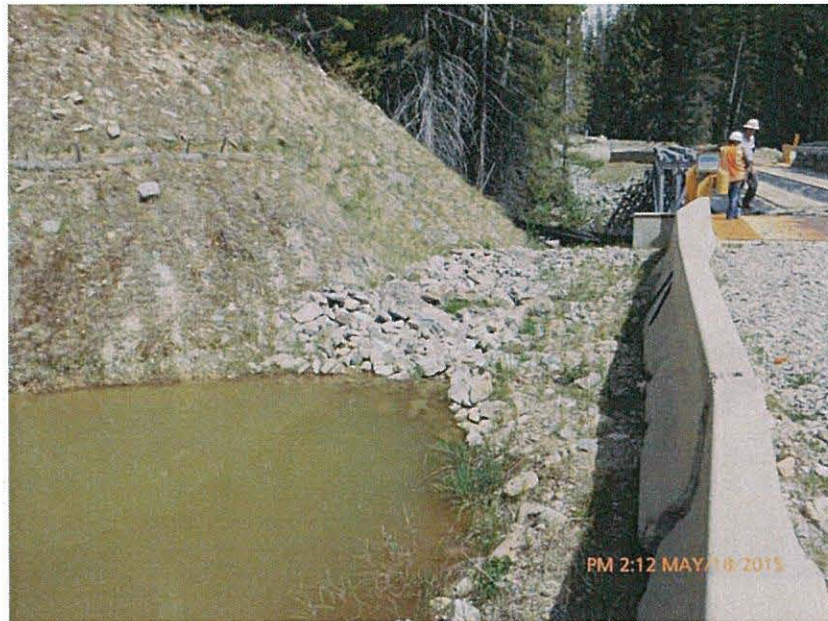
Photo No. 22 (P1010211)

Facing east – this small sediment basin was constructed to prevent sediment from flowing into the LNF.

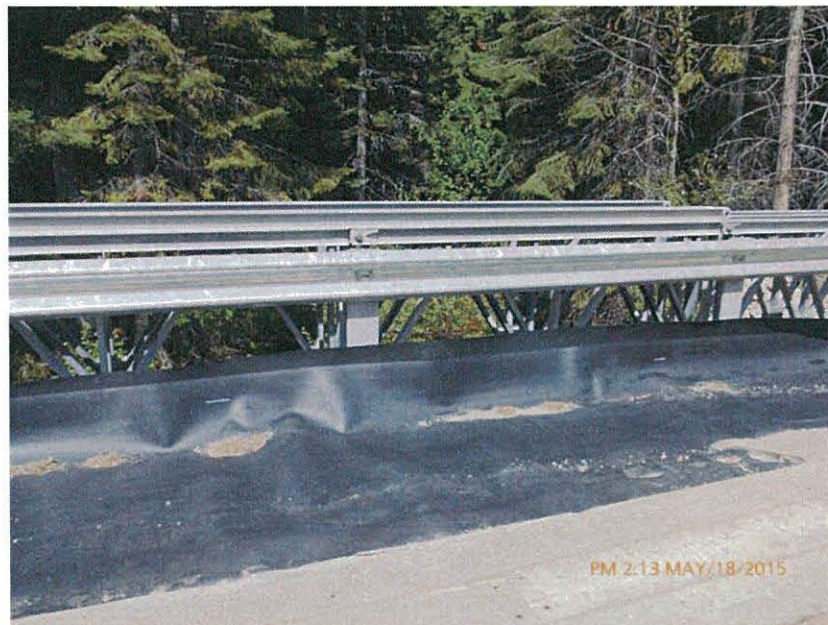
Photo No. 23 (P1010212)

Facing northeast – this plastic skirting was installed along both sides of the bridge spanning the LNF to keep sediment out of the river.

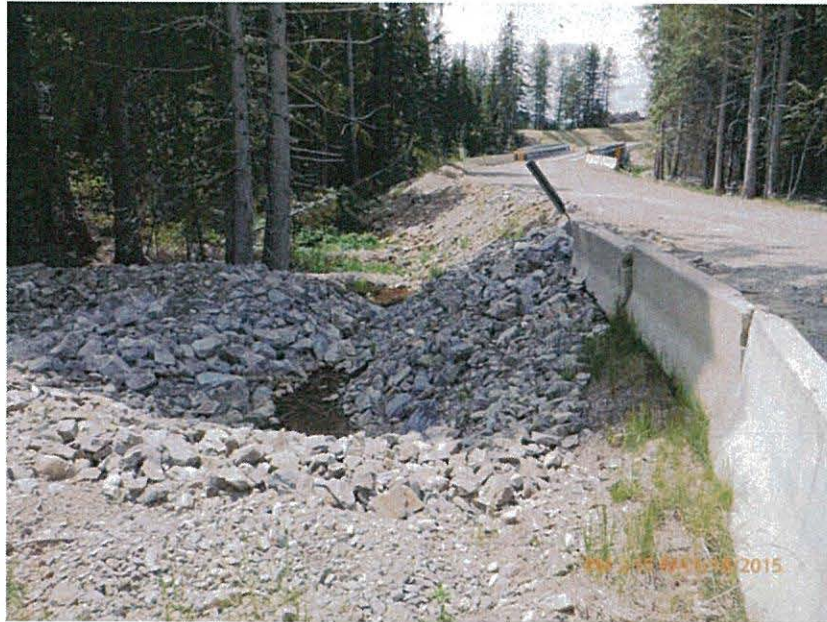
Photo No. 24 (P1010213)

Facing west from the borrow source side of the LNF – these rock check dams were installed after the November 2012 discharge to the LNF and the Hale Fish Hatchery.

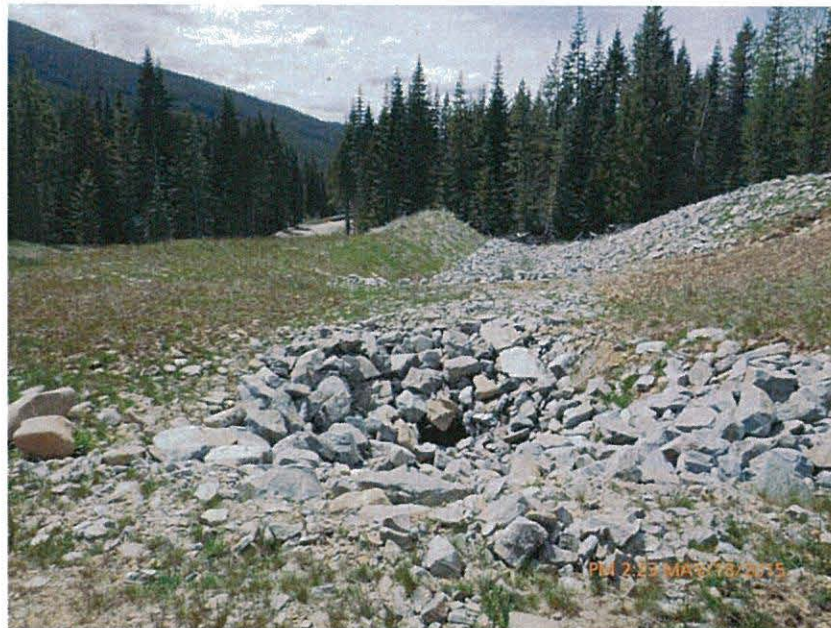
Photo No. 25 (P1010216)

Facing west – the former borrow source area has been seeded and grasses are growing in the area. A number of erosion and sediment control features remain in place.

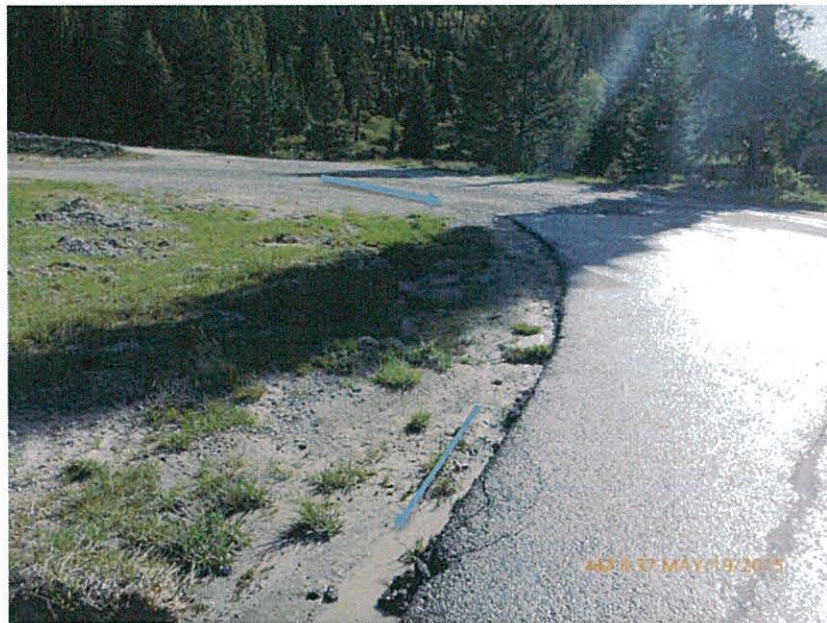
Photo No. 30 (P1010222)

Facing northeast – this is the location where the gravel road from the Silver Mountain Dump intersects Larson Road. I observed evidence of sediment flowing down the borrow ditch.
